**FEDERAL AVIATION ADMINISTRATION
AIRWORTHINESS DIRECTIVES
SMALL AIRCRAFT, ROTORCRAFT, GLIDERS,
BALLOONS, & AIRSHIPS**

BIWEEKLY 2010-21

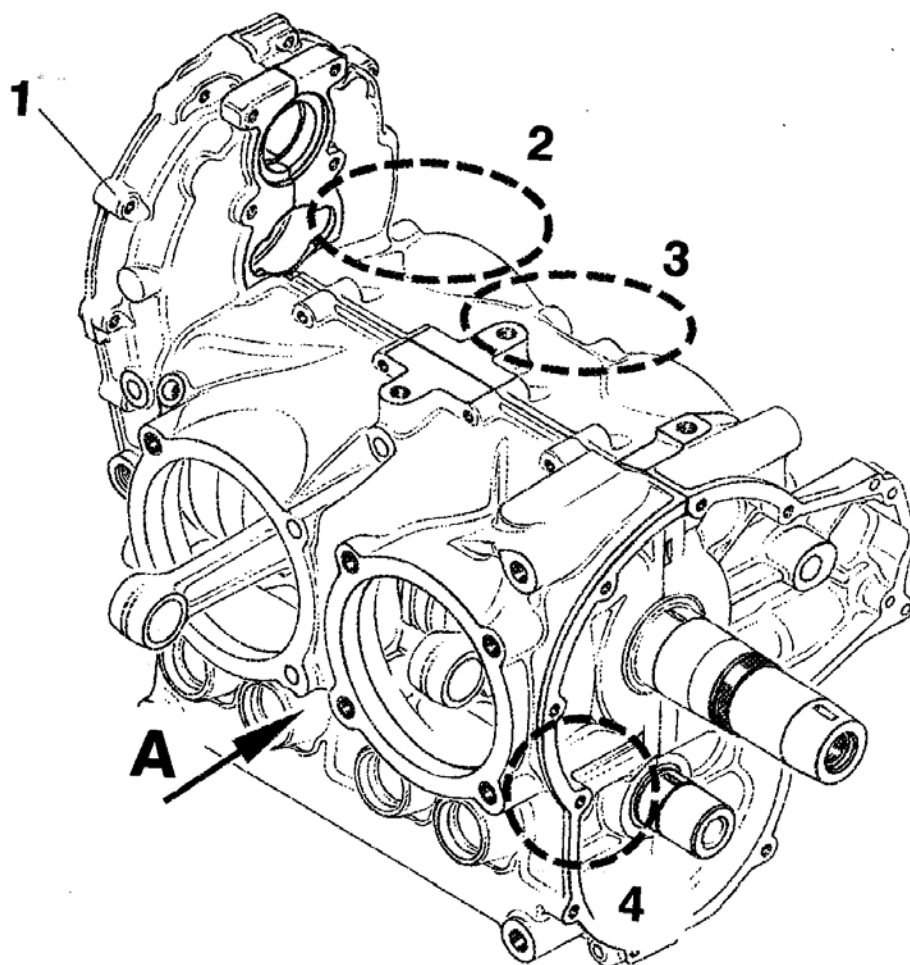
Figure 1. Engine Crankcase Inspection Areas

(1) Inspect the engine crankcase (item 1, Figure 1 of this AD) for cracks especially in the area of cylinder 1 upper side (item 2), between cylinder 1 and 3 upper side (item 3), cylinder 4 lower-right

side (item 4) and detailed inspection in the area identified in Figure 2 (item 5) of this AD. Information concerning this inspection can be found in Bombardier-Rotax Mandatory Service Bulletins No. SB-912-029, Revision 3, dated July 11, 2006 and No. SB-914-018, Revision 3, dated July 11, 2006.

(2) Cracks in crankcases of engines with a ROTAX cooling air baffle may not be easily visible, and oil leaks may be an indication of cracks. Visually inspect for oil leaks in areas of cylinder 1 upper side (item 2, Figure 1 of this AD) and between cylinder 1 and cylinder 3 upper side (item 3).

(3) If you find oil leaks, determine the source by either using a borescope or removing the object blocking the view such as the air baffle or accessory, and perform the inspection.

(4) If the engine crankcase is cracked, remove the engine from service before further flight.
